RANGE REVIEW: Pakistan Ordnance Factory No4Mk2 Lee Enfield

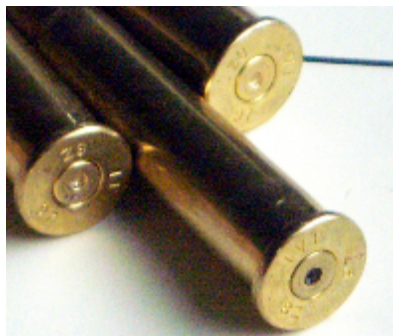
3. I had a pierced primer on the tenth round. It was the only round to show any signs of pressure. The primer was completely pancaked and the primer strike was blackened. I expect this may have affected my group size somewhat by at least one stray bullet. I don't think the rifle has anything to do with it. This particular round seemed overly 'Hot'.

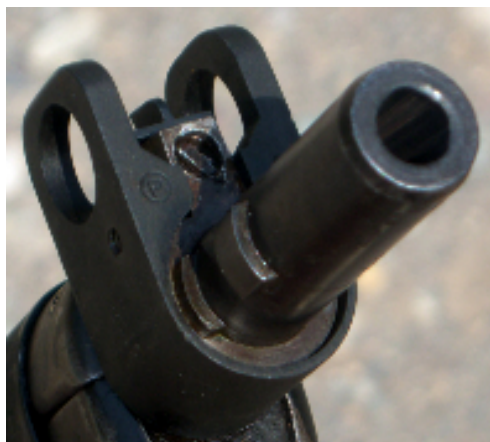
5. The crown is not even. I don't like what POF did here. The rifling seems shallow at the muzzle in comparison to my Can Ranger Rifle (Thank You your Majesty for the 1950 Long Branch CNo4Mk1*) although it has in the neighborhood of 25000 rounds (I'm guessing on that number) through it the crown and muzzle rifling are still better than this POF. Although I believe the POF has a new barrel on it manufacturing tolerances seem to be different.

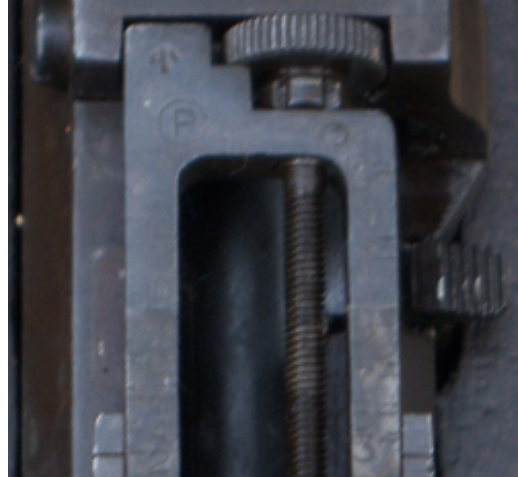
2. At some point this rifle was Full Trough Re-arsenalled (although not FTR marked). I don't know if the Indians did this or if it was done by Pakistan. The receiver lacks finish and has visible areas of staining but no pitting or frost. The bolt, magazine, front sight protector, sight base and most other fixtures have received new Parkerizing. The rifle has also been re-barreled at some point. All numbers match (even this beat-up stock) and are P circle marked.
